# Pier Damage Analysis

Condition timeline, likely causes, responsible parties, recovery outlook and repair estimate

Cover: fender-pile and tie damage at the pier, Hampton River, Hampton, Virginia. Location 37°01'50.0"N, 76°20'12.6"W. Photographs by the Dock Master, October 13, 2026.

| Date / version | October 16, 2026 Version 4 |

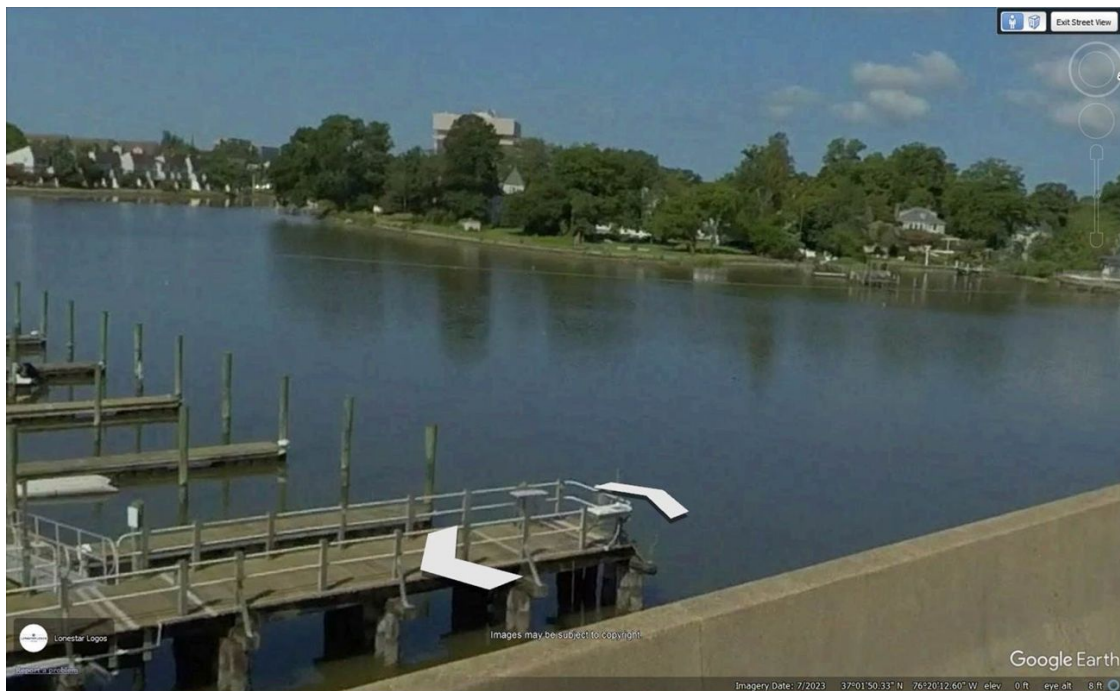
Figure 1. Google Earth Street View, imagery date July 2023 (GE1), taken from the old eastbound bridge sidewalk at 37°01'50.33"N, 76°20'12.60"W. The end platform is intact: pipe rail and posts straight, pile caps seated, diagonal cross-bracing in place under the deck, floating docks level, no barges. Independent third-party evidence of pre-construction condition, and of how close the platform sits to the bridge.

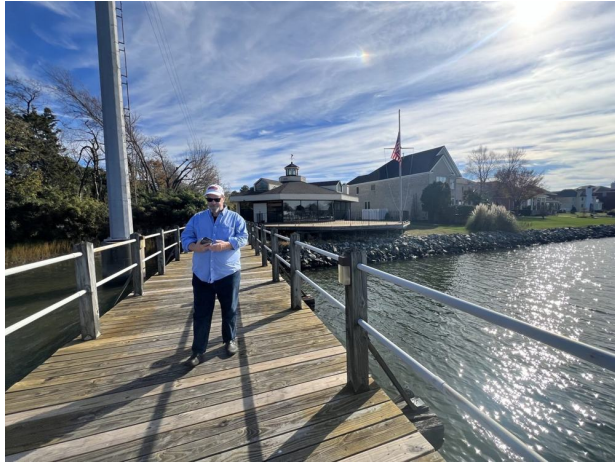
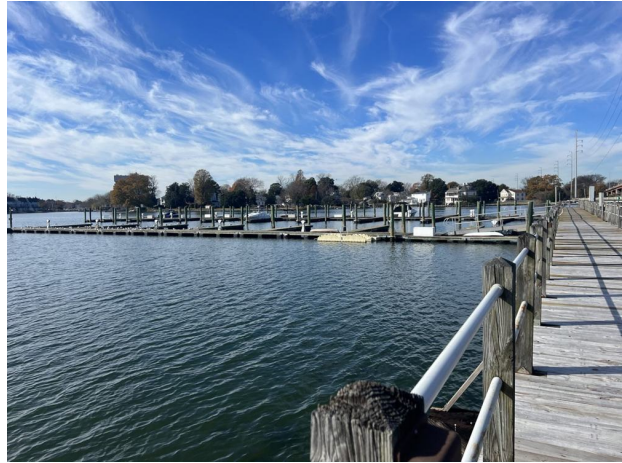
Figure 2. Baseline, November 20, 2023 (A03, A04). Deck line level, rails straight, the diagonal pile-to-post tie at the right-hand rail post fully seated; slips full; no barges or cranes near the pier.

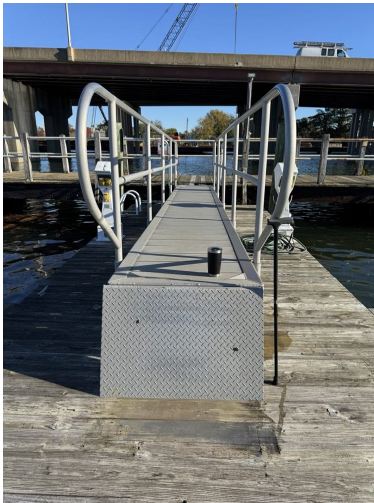
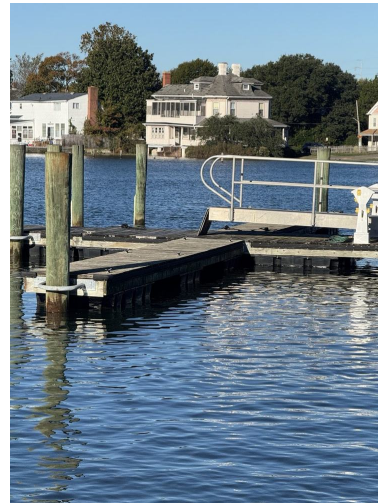
Figure 3. Baseline, November 16, 2024 (B01, B02). Gangway and float landing level; guide piles and floating docks square. A crane boom is visible above the old bridge, consistent with the westbound widening then under way.

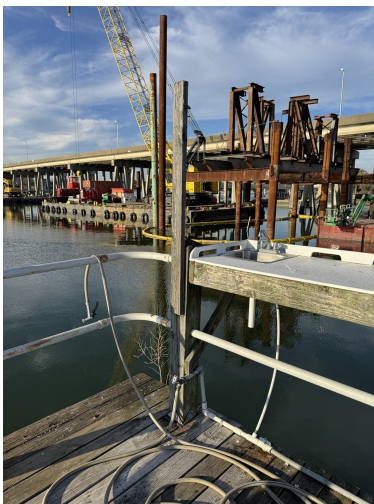
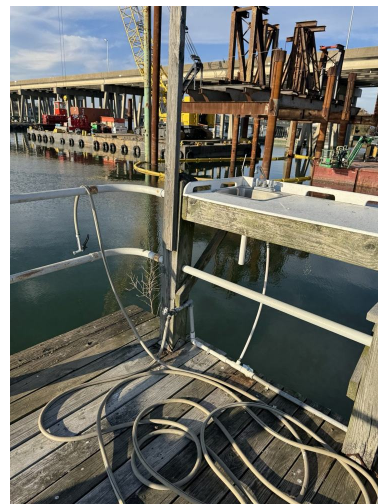
Figure 4. November 8, 2025 (C01, C03). From the fish-cleaning station: contractor work barge with crane cab and containers, crawler-crane barge, steel falsework towers and pipe piles for the new eastbound span, and an orange turbidity boom, all within a few hundred feet of the pier. The pier itself is intact in frame.

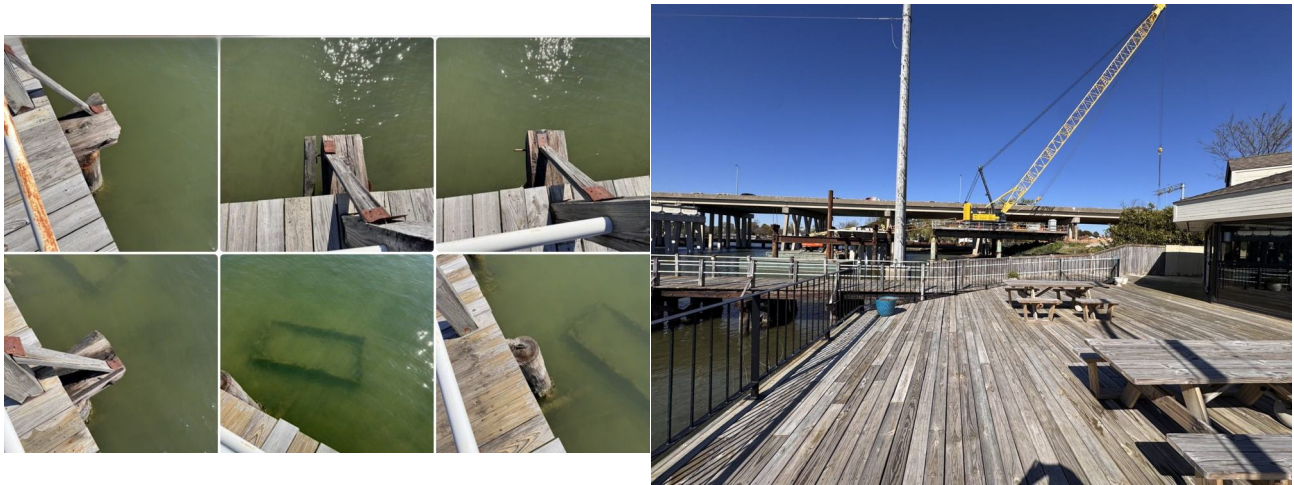
Figure 5. March 24, 2026 (D01 composite, D05). Left: pile-to-post ties pulled off their pile tops with the steel connector plates hanging; a split pile top; and a rectangular timber frame lying on the bottom beside the pier. Right: the old eastbound span still carrying traffic with the new concrete bents and a crawler crane immediately abeam of the upper deck.

| Component | Condition observed (photo IDs) | First seen | Severity |
|---|---|---|---|
| Pile-to-rail-post diagonal ties and steel connector plates | Ties detached from pile tops with plates hanging in March (D01, D04, D07). By October most ties rest unfastened: through-bolts backed out of the pile tops (H02, H03, H19, H23, H25, H28, H44), plates corroded and distorted (H21, H41, H53), several ties cracked or displaced (H22, H29, H33, H61). Condition repeats along the length of the pier (H01-H06, H15-H25, H28-H35, H37-H47, H52-H61). Close-ups on Oct 14 show the mechanism: the brackets are light-gauge galvanized angle plates screwed to the braces, and they are intact; the timber caps under them are delaminated, split and crushed down to the bracket line (I11-I14, I17, I19, I25-I28), through-bolts are driven out with bare threads exposed (I08, I12, I13, I23, I31), and one bracket has been torn off its cap and bent back (I09). | Mar 24, 2026 | High - rail posts are no longer tied to the piles |

| Component | Condition observed (photo IDs) | First seen | Severity |
|---|---|---|---|
| Submerged debris | Rectangular timber frame section lying on the bottom beside the pier (D01, two angles). Origin not identified; may be a pier or float component. Hazard to boats and props. On Oct 14 a timber stub stands out of the water beside the pier at low tide (I04), and a gnarled cross-brace is visible submerged under the deck (I05). | Mar 24, 2026 | Moderate - identify and recover |

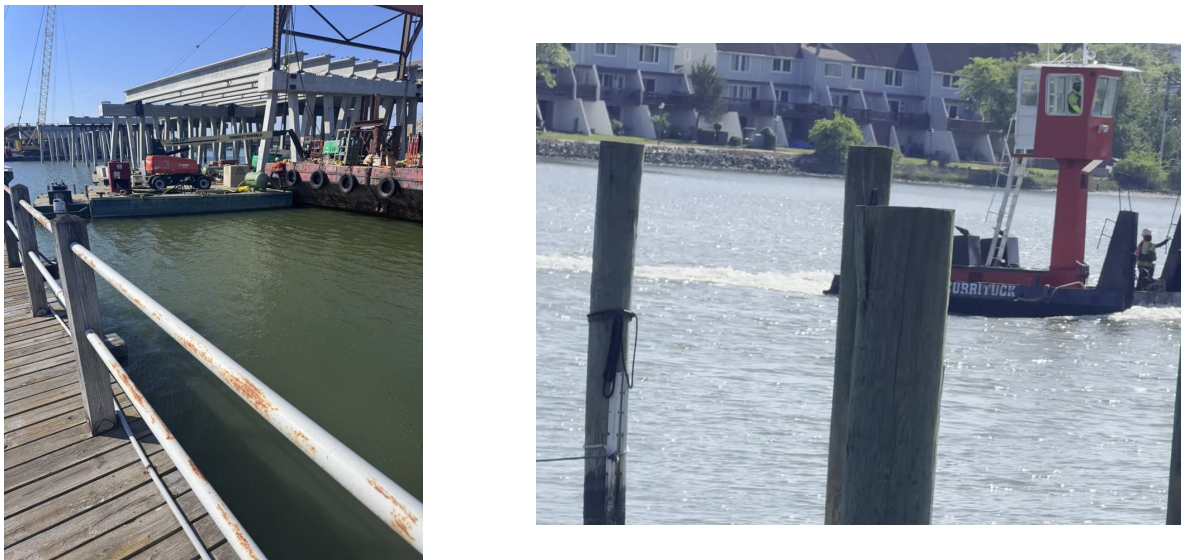
Figure 6. May 4, 2026 (E01; video V2 frame). Left: the contractor's green equipment barge moored immediately alongside the pier's outboard pile line with the red tire-fendered crane barge rafted outside it and a worker crossing between the two barges; no camel, fender or standoff structure between the barges and the pier. Right: push boat CURRITUCK at speed inside the basin, name visible, its wake trailing across the water toward the slips (4:35 PM).

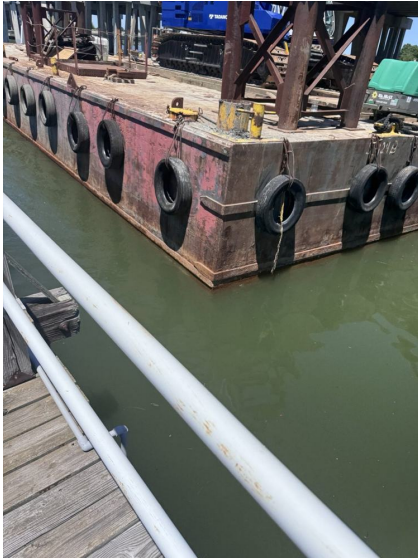
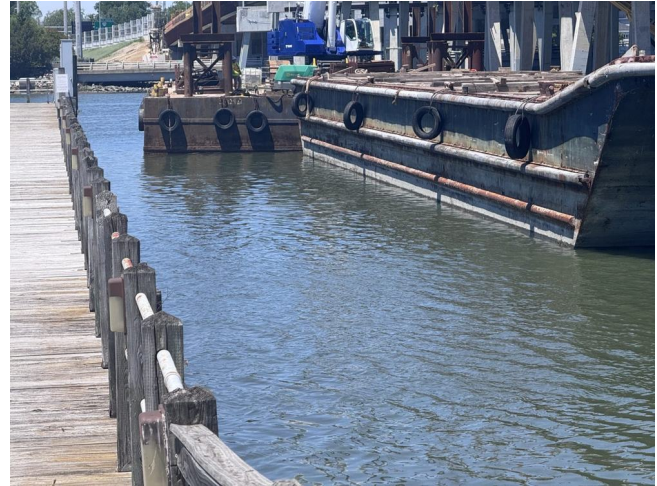
Figure 7. May 16, 2026 (F04, F14). Left: the crane barge's hull and tire fenders a few feet off the pier's outboard pile line and facing the piles, with a TADANO crane and generator aboard; hull marking ending 124 B. Right: two barges moored at the end of the pier with girder erection in progress behind them.

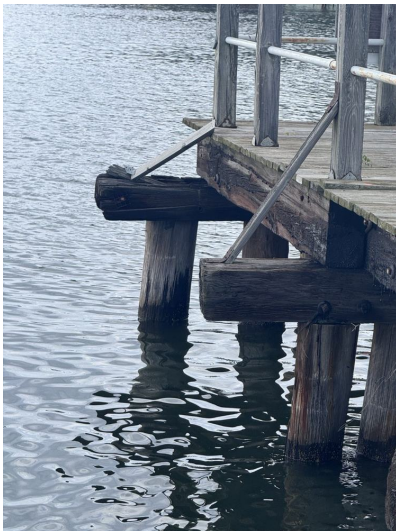
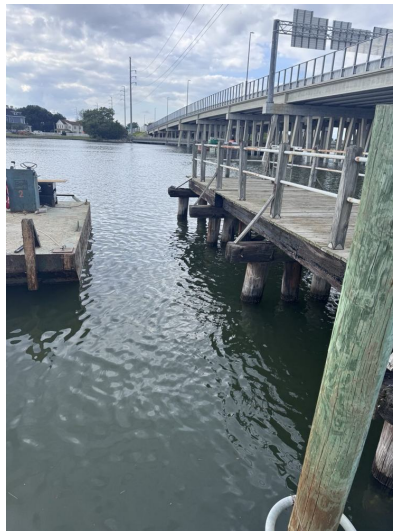
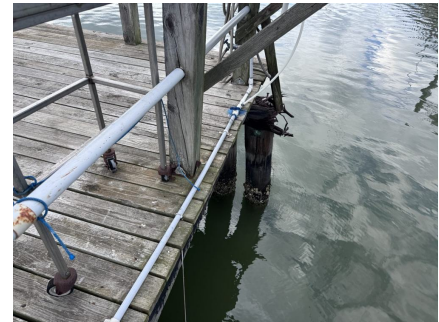
Figure 8. September 18, 2026 (G01, G05, G17). Left: the end platform's outer cap beam cantilevered past its pile, the knee brace sheared with its plate hanging, and the lower wale separated from the pile face. Center: the same corner with the contractor's work barge (marked 2) moored at the end of the pier. Right: the pile beside the gangway with its top shattered to splinters.

| Component | Condition observed (photo IDs) | First seen | Severity |
|---|---|---|---|
| End platform structure (cap beam, knee braces, wale) | Outer cap beam displaced and cantilevered past its pile; knee brace sheared with plate hanging; lower wale separated from the pile face (G01, G02, G05). Same corner the barges were moored beside in May and September. Water-side views on Oct 14 (I03, I05, I07) show the cap beam's end bearing on nothing, the knee-brace plate torn from the pile, and a corroded through-bolt in the main cap beam with its nut backed off (I06); a sister-brace bolt is bent (I02). | Sep 18, 2026 | High - structural |

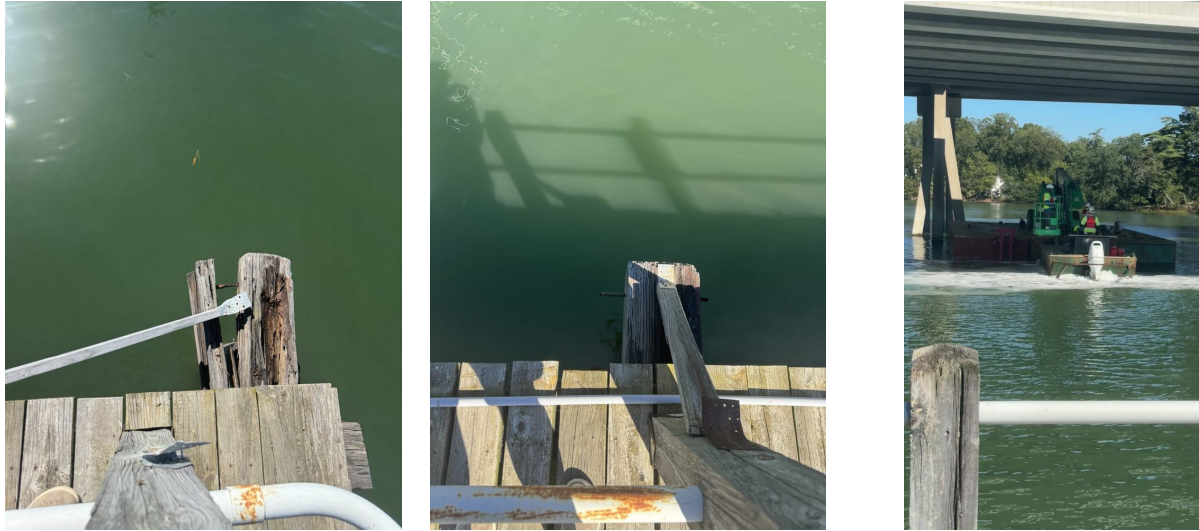
Figure 9. October 13, 2026 (H08, H02; video V5 frame). Left: an outboard pile split through, with decay exposed in the core. Center: a typical tie on the post-construction survey, resting unfastened on the pile top with its through-bolt backed out (bolt visible beside the tie) and the connector plate corroded. Right: a motorized work barge with a lift unit maneuvering under the new spans beside the pier at 1:16 PM, propeller wash visible, on the day the bridge work concluded.

| Component | Condition observed (photo IDs) | First seen | Severity |
|---|---|---|---|
| Outboard fender / guide piles (timber, cut off at deck level) | At least four pile tops split or shattered: split through with core decay (H08, H09); shattered to splinters at the end platform beside the gangway (H10-H12, G15, G17, cover; intact in July 2023, Figure 13); split in two halves (D02); hairline split (H48). Others chipped or crushed at the top (D04, D07, H38). | Mar 24, 2026 | High |

Steel connector plates and pipe rails show corrosion consistent with years of brackish exposure, and one split pile shows internal decay (H08). The contractor's insurer will attribute the damage to age. The record answers this in three ways: the pier was intact and serviceable in July 2023 (Google Street View, including the very pile that is now shattered, Figure 13), November 2023, November 2024 and November 2025; the damage appeared only during the construction window and is concentrated where the barges lay; and a party that damages a structure takes it as it finds it, with any betterment handled by a new-for-old adjustment to the repair cost rather than a denial of liability. If the contractor attributes the damage to weather, the Association should pull NOAA wind and tide records for the intervals between photo sets.

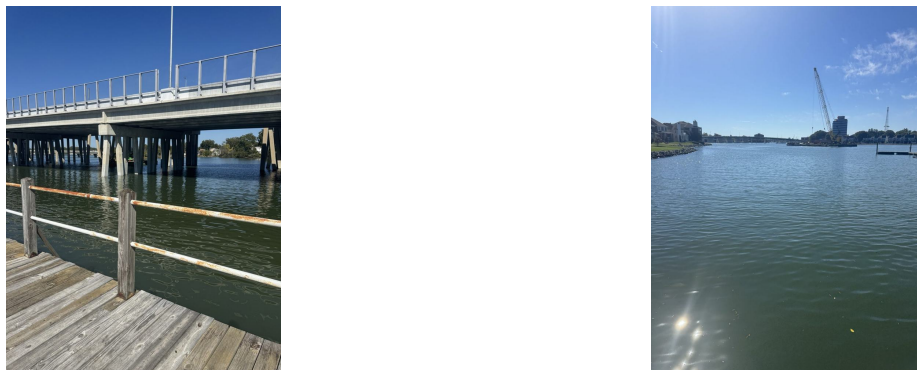
Figure 10. October 13, 2026 (H50, H51). The completed bridge from the pier, and the crane barge still in the river beyond the floating docks.

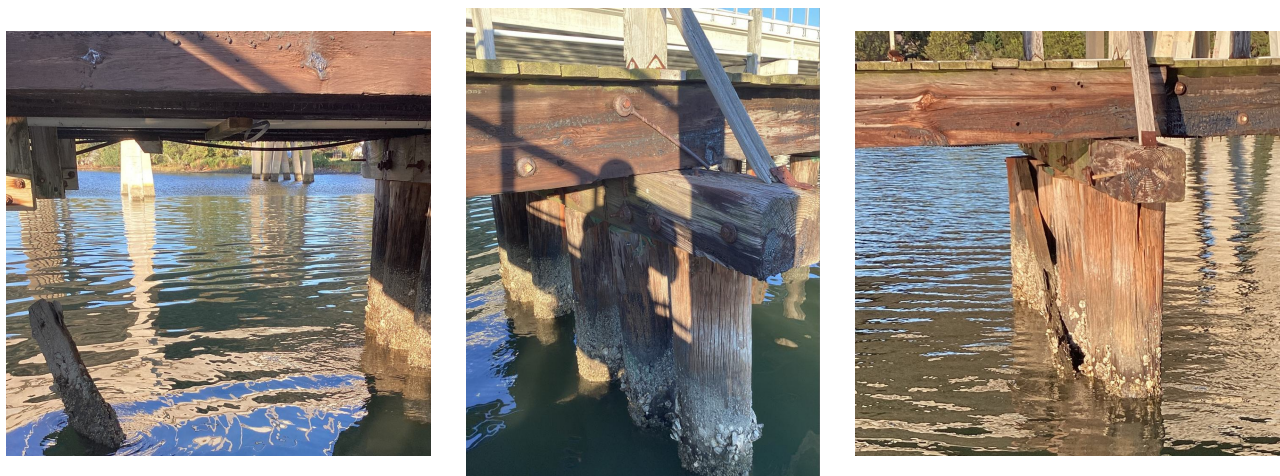
Figure 11. October 14, 2026 (I04, I03, I07). Left: from under the deck, the new eastbound bridge's concrete pile bents standing a few feet off the pier's under-deck bracing, with a timber stub standing out of the water beside the pier. Center and right: the end-platform corner from the water side, the outer cap beam cantilevered past its pile and the knee brace sheared at its plate; oyster growth marks the tide line on every pile.

| Component | Condition observed (photo IDs) | First seen | Severity |
|---|---|---|---|
| Bearing piles, caps and stringers under the deck; everything below the waterline | Seen only from the water side at low tide (I02-I07): cap beams, through-bolts and under-deck cross-bracing are visible, with oyster growth to the tide line. Nothing below the waterline has been inspected. The end-platform cap displacement, the loosened cap-beam bolt and the timber on the bottom make underwater damage to piles and bracing probable. | Unknown | Unknown - dive and drone survey required |

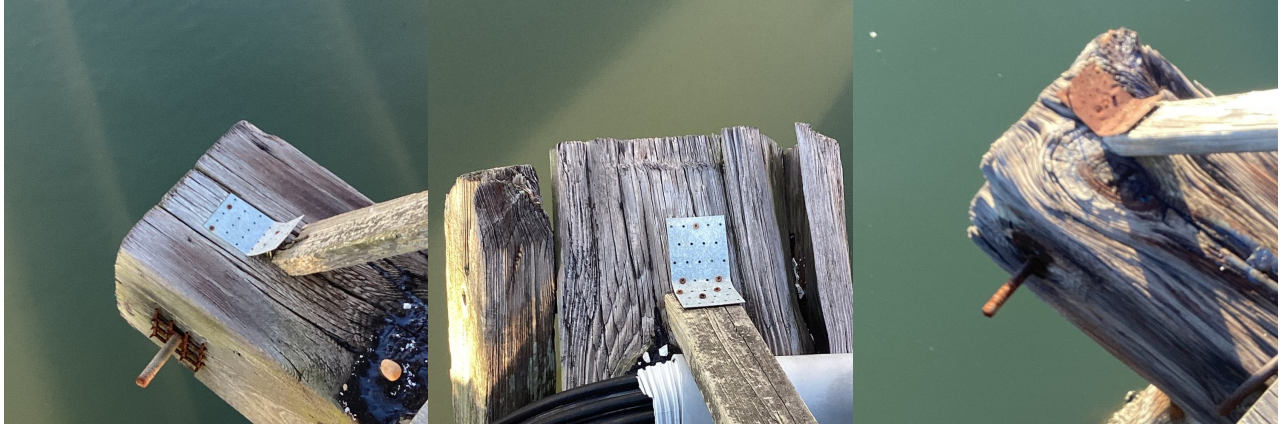
Figure 12. October 14, 2026 (I12, I14, I23). Pile caps from directly above. Left: a through-bolt driven out of a cap with its threads bare and the brace plate lifting. Center: a cap delaminated and split down to the bracket line; the light-gauge galvanized angle bracket is intact and still screwed to the brace. Right: a cap end split with the bolt pushed out. The brackets are not failing; they are screwed to is.

The October 14 close-ups add a mechanical detail that matters for causation. The pile-to-post ties are fastened with light-gauge galvanized angle brackets screwed to the brace ends, and those brackets are almost all intact (I11-I14, I17-I19, I25-I28). What has failed is the timber around them: pile caps delaminated and split down to the bracket line, through-bolts driven out of the caps and the cap beam with their threads exposed (I06, I08, I12, I13, I23), and one bracket torn out of its cap and bent back (I09). Corrosion loosens a connection slowly and evenly; it does not split a cap or push a bolt out of it. Splitting along the grain at bolt holes and bolts driven outward are what repeated lateral shock produces when the structure is struck or shoved from the outboard side.

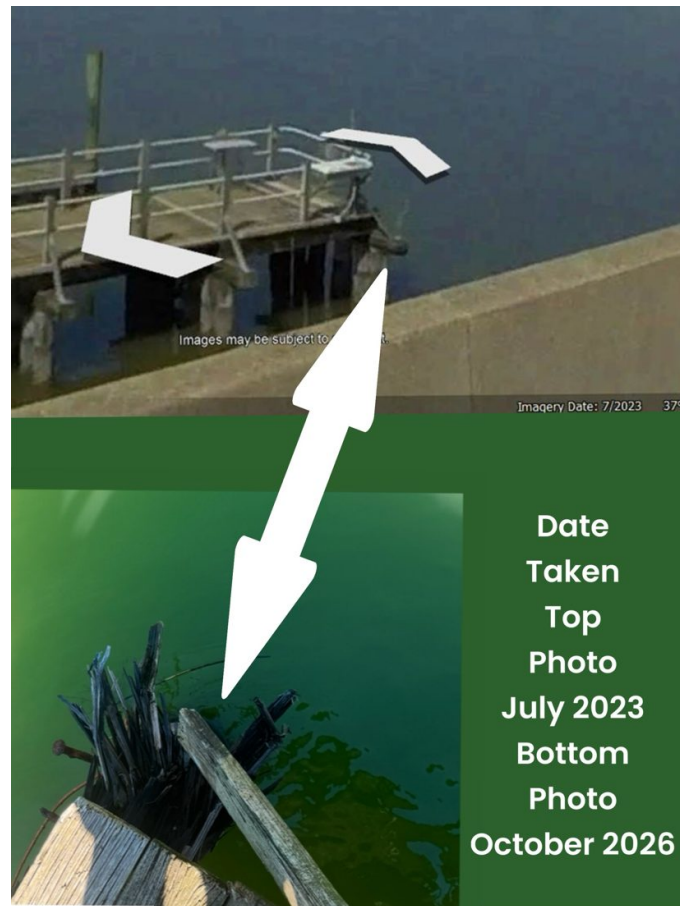
Figure 13. Same pile, before and after (GE2). Top: the corner guide pile at the end platform beside the gangway, intact with its cap and tie in Google Street View imagery dated July 2023. Bottom: the same pile on October 13, 2026, its top shattered to splinters with the tie displaced (also H10-H12 and the cover).

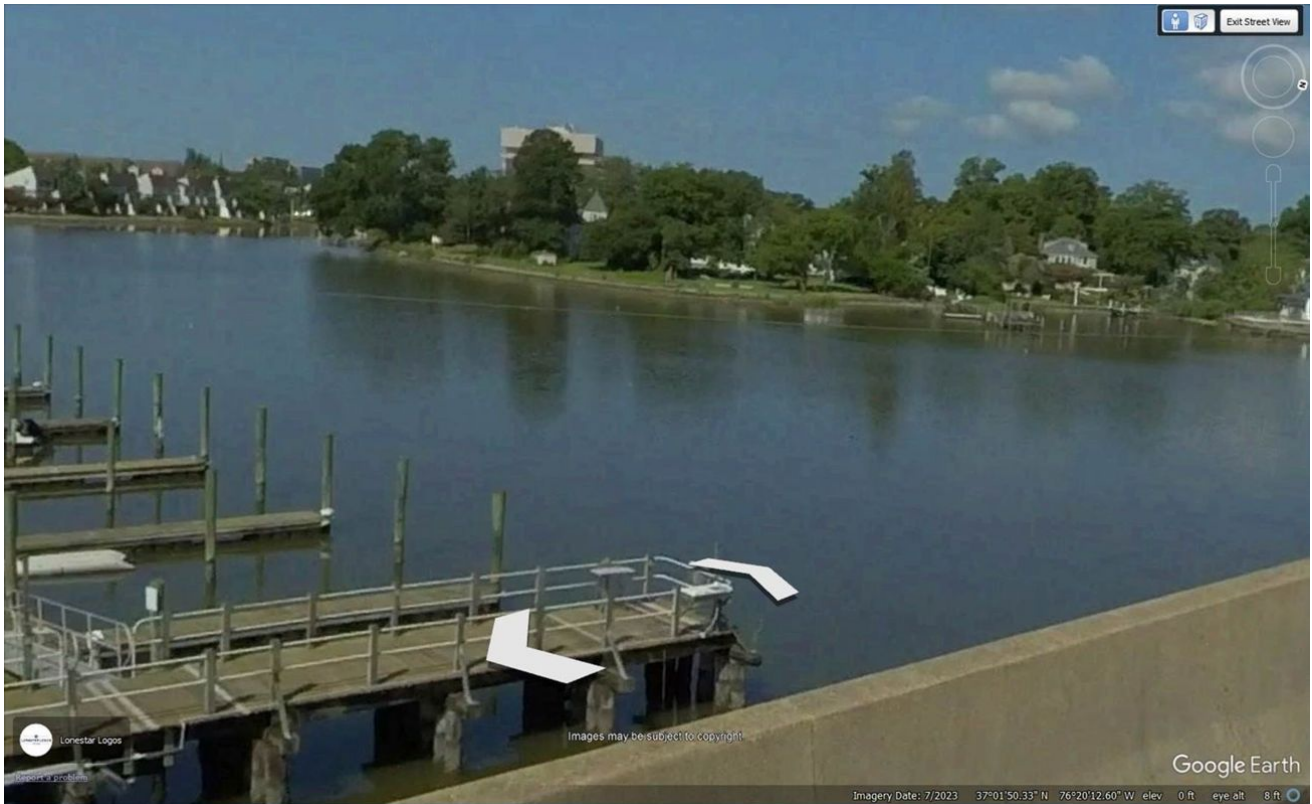
GE1 - Google Earth Street View, imagery date July 2023, from the old eastbound bridge sidewalk (37°01'50.33"N, 76°20'12.60"W). End platform, rail, pile caps and cross-bracing intact; floating docks level; no barges. Screenshot supplied by the Dock Master; imagery copyright Google.

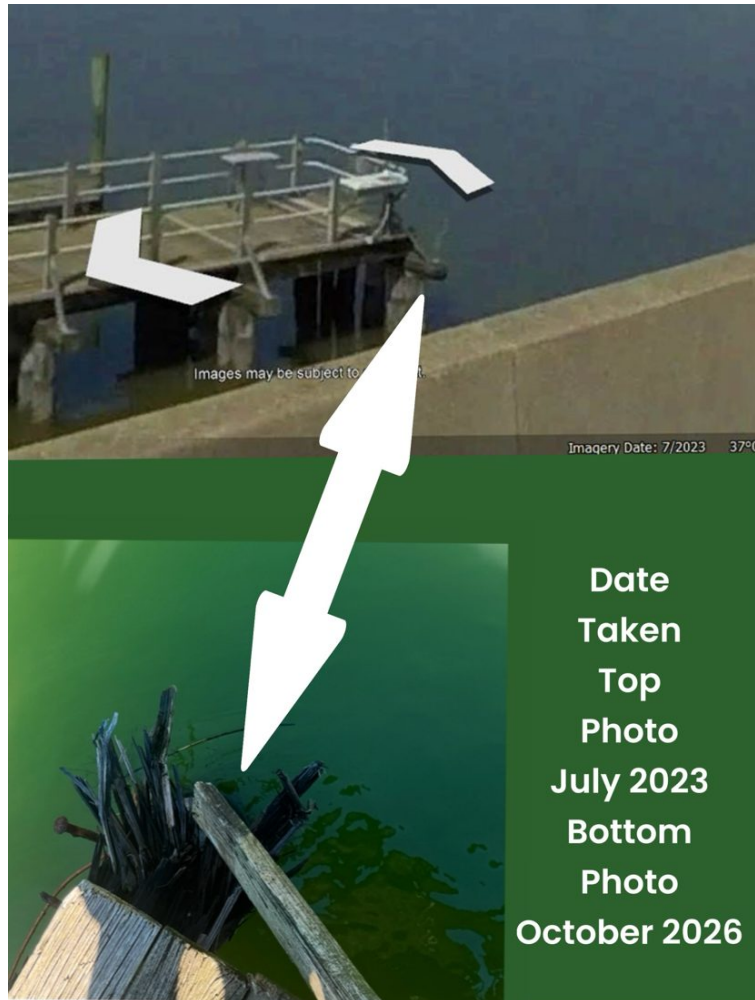
GE2 - Before-and-after composite prepared by the Dock Master: the corner guide pile at the end platform in Google Street View imagery dated July 2023 (top) and on October 13, 2026 (bottom).

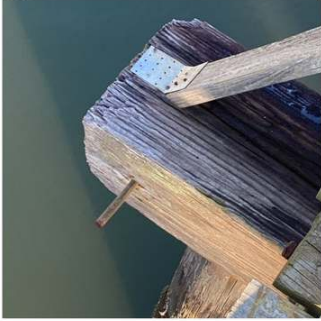
**I13**

Set I, continued. I13: cap end split, bolt out. I14: cap delaminated under an intact bracket. I15, I17, I19, I20: further caps with brackets intact and timber failed beneath. I16: rust streaks on the pipe rails at a post bracket. I18: the one intact PVC-capped post beside a failed cap (reference condition). I21: the new bents from the pier. I22: cable run and conduit at the deck edge. I23, I24: caps with bolts driven out and brackets lifting.

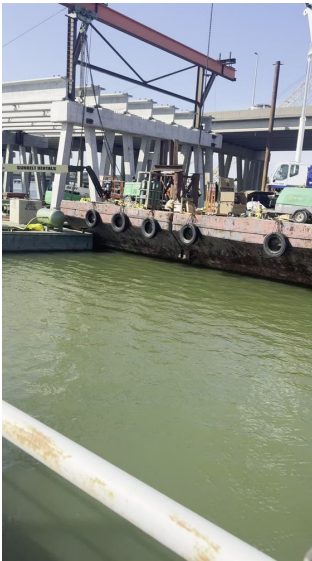
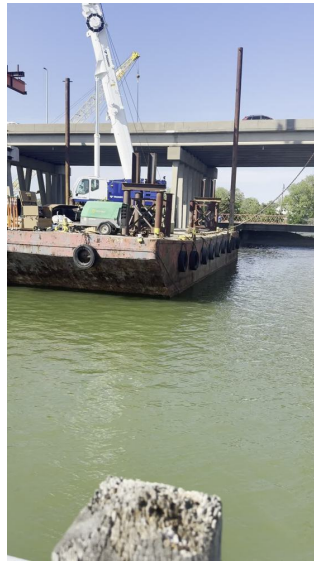
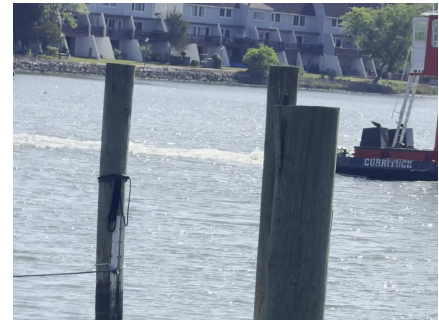
V1 frames (left, center): equipment barge and crane barge moored alongside the pier, hull marking visible; V2 frame (right): CURRITUCK's wake trailing across the basin toward the floating docks.

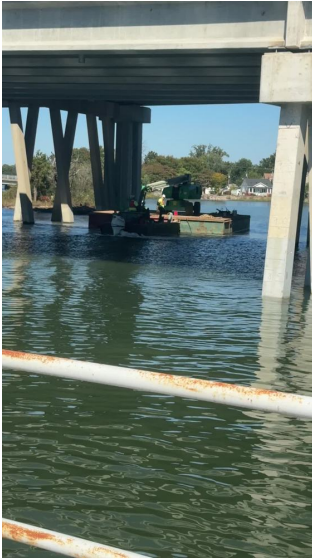
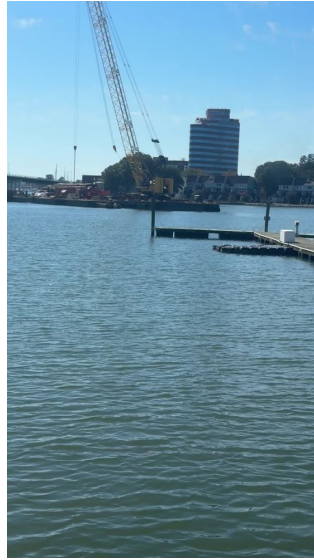
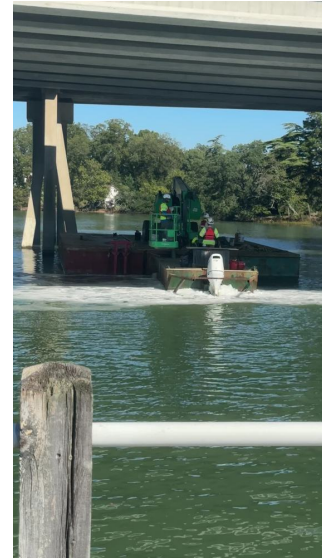
V3, V4 and V5 frames, October 13, 2026: work barge under the new spans, crane barge in the river, propeller wash beside the pier.
