# Pier Damage Analysis

Condition timeline, likely causes, responsible parties, recovery outlook and repair estimate

Cover: fender-pile and tie damage at the pier, Hampton River, Hampton, Virginia. Location 37°01'50.0"N, 76°20'12.6"W. Photographs by the Dock Master, October 13, 2026.

| Date / version | October 16, 2026 Version 4 |

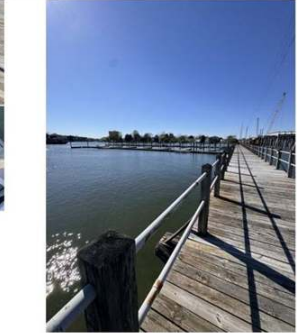
**D08**

Set D - March 24, 2026 (15 files, four of them six-frame composites). D01: ties detached at pile tops with plates hanging; timber frame on the bottom (two angles). D02: split pile top, corroded rail, locate-marked cable, ties resting unfastened. D03/D05/D06/D09: upper deck platform with the old span in service and the new bents and crawler crane immediately abeam. D04/D07: pile tops with displaced plates, ties loose. D08/D10/D13/D15: walkway, deck line level. D11: green deck barge off the pier end. D14: crane on the old deck and turbidity boom.

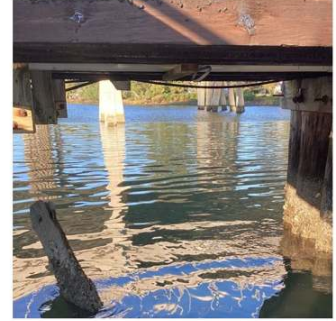
**I04**

Set I - October 14, 2026 (31 files). I01: the walkway and the completed bridge. I02-I07: substructure from the water side at low tide: cap beams, through-bolts and cross-bracing (I02, bent sister-brace bolt); the end-platform cap beam cantilevered past its pile with the knee-brace plate torn off (I03, I05, I07); the new concrete bents a few feet off the under-deck bracing and a timber stub standing out of the water (I04); corroded through-bolt with nut backed off the cap beam (I06). I08-I12: pile caps from above: bolt driven out of a cap (I08); bracket torn off its cap and bent back (I09); the shattered gangway pile from above with its bolt standing in the splinters (I10); caps split at the bracket line with bolts pushed out (I11, I12).

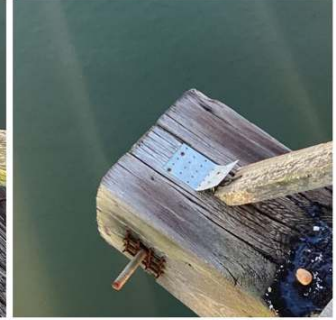
**I12**

Figure 12. October 14, 2026 (I12, I14, I23). Pile caps from directly above. Left: a through-bolt driven out of a cap with its threads bare and the brace plate lifting. Center: a cap delaminated and split down to the bracket line; the light-gauge galvanized angle bracket is intact and still screwed to the brace. Right: a cap end split with the bolt pushed out. The brackets are not failing; they are screwed to is.

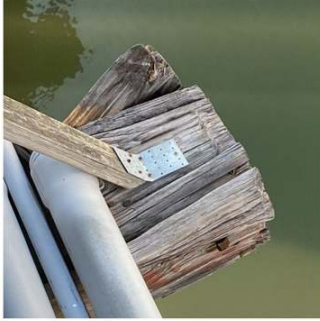
**I15**

Set I, continued. I13: cap end split, bolt out. I14: cap delaminated under an intact bracket. I15, I17, I19, I20: further caps with brackets intact and timber failed beneath. I16: rust streaks on the pipe rails at a post bracket. I18: the one intact PVC-capped post beside a failed cap (reference condition). I21: the new bents from the pier. I22: cable run and conduit at the deck edge. I23, I24: caps with bolts driven out and brackets lifting.

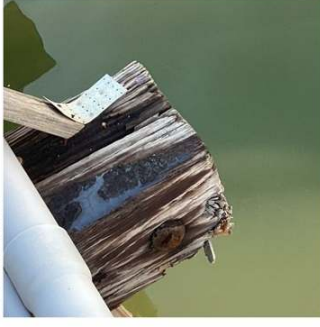
**I19**

| Component | Condition observed (photo IDs) | First seen | Severity |
|---|---|---|---|
| Pile-to-rail-post diagonal ties and steel connector plates | Ties detached from pile tops with plates hanging in March (D01, D04, D07). By October most ties rest unfastened: through-bolts backed out of the pile tops (H02, H03, H19, H23, H25, H28, H44), plates corroded and distorted (H21, H41, H53), several ties cracked or displaced (H22, H29, H33, H61). Condition repeats along the length of the pier (H01-H06, H15-H25, H28-H35, H37-H47, H52-H61). Close-ups on Oct 14 show the mechanism: the brackets are light-gauge galvanized angle plates screwed to the braces, and they are intact; the timber caps under them are delaminated, split and crushed down to the bracket line (I11-I14, I17, I19, I25-I28), through-bolts are driven out with bare threads exposed (I08, I12, I13, I23, I31), and one bracket has been torn off its cap and bent back (I09). | Mar 24, 2026 | High - rail posts are no longer tied to the piles |

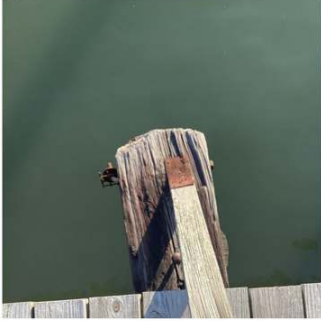
**I25**

Set I, continued. I25-I28: caps and braces along the outboard rail; brackets intact, caps split. I29: the end platform and the shattered gangway pile from the walkway. I30-I31: braces and caps along the walkway with the bridge bents behind.
